# LASER-INDUCED DAMAGE THRESHOLD (LIDT) MEASUREMENT REPORT

## LIDT ISO S-ON-1 TEST PROCEDURE

SAMPLE: CAM364-A2-5

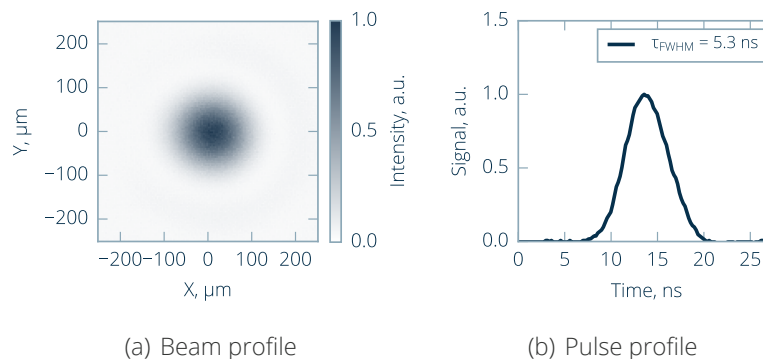
Figure 1. Laser parameters used for measurements.

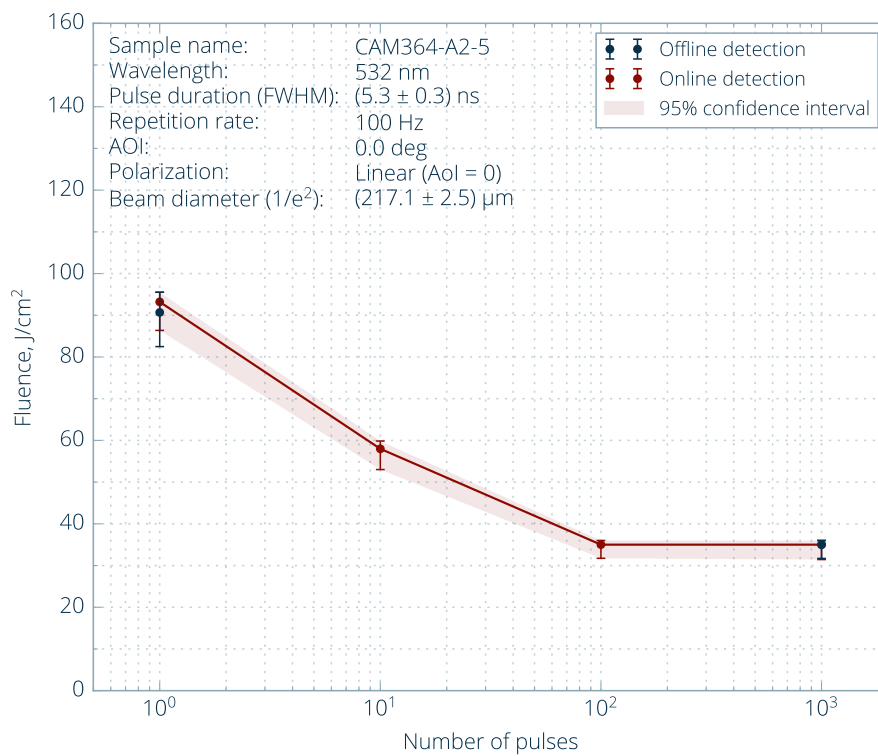
Figure 2. Characteristic damage curve.

Table 1: Estimated LIDTs from fitting model for sample CAM364-A2-5.

| Test mode | Threshold (Offline detection - microscopy) | Threshold (Online detection - scattering) |
| 1-on-1 | $90.7^{+4.8}_{-8.2} \text{ J/cm}^2$ | $93.2^{+2.3}_{-6.8} \text{ J/cm}^2$ |
| 10-on-1 | - | $58.0^{+1.9}_{-5.0} \text{ J/cm}^2$ |
| $10^2$ -on-1 | - | $35.0^{+1.0}_{-3.3} \text{ J/cm}^2$ |
| $10^3$ -on-1 | $35.0^{+1.0}_{-3.3} \text{ J/cm}^2$ | $35.0^{+1.0}_{-3.6} \text{ J/cm}^2$ |

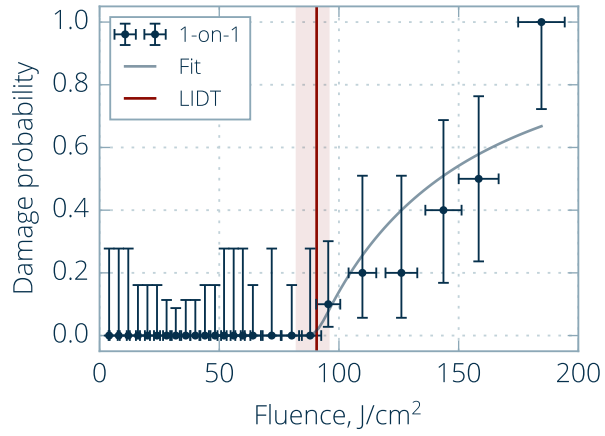
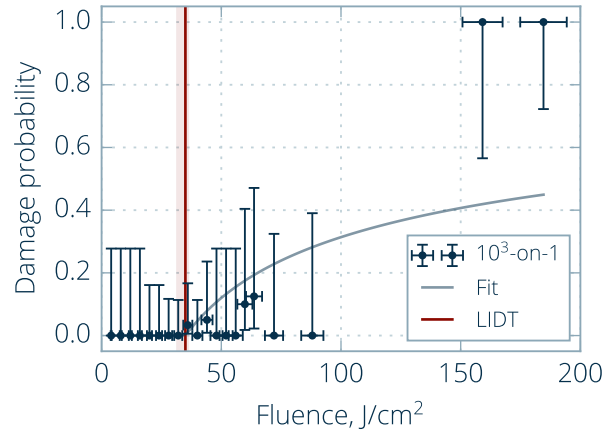
(a) 1-on-1

(b) 10<sup>3</sup>-on-1

Figure 3. Damage probability plots.

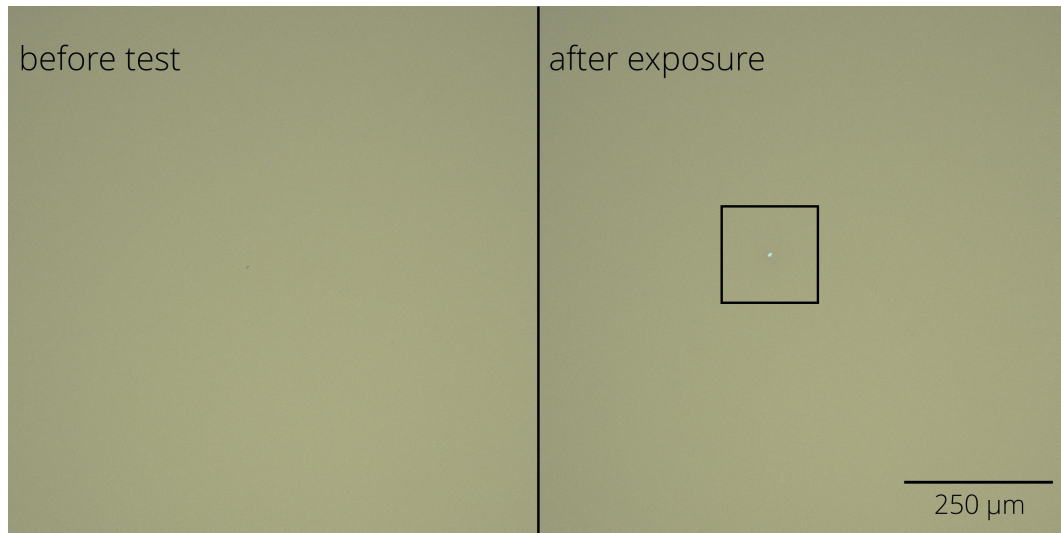
Figure 4. Typical damage morphology: fluence  $36.1 \text{ J/cm}^2$ , damage after 1000 pulse(s).

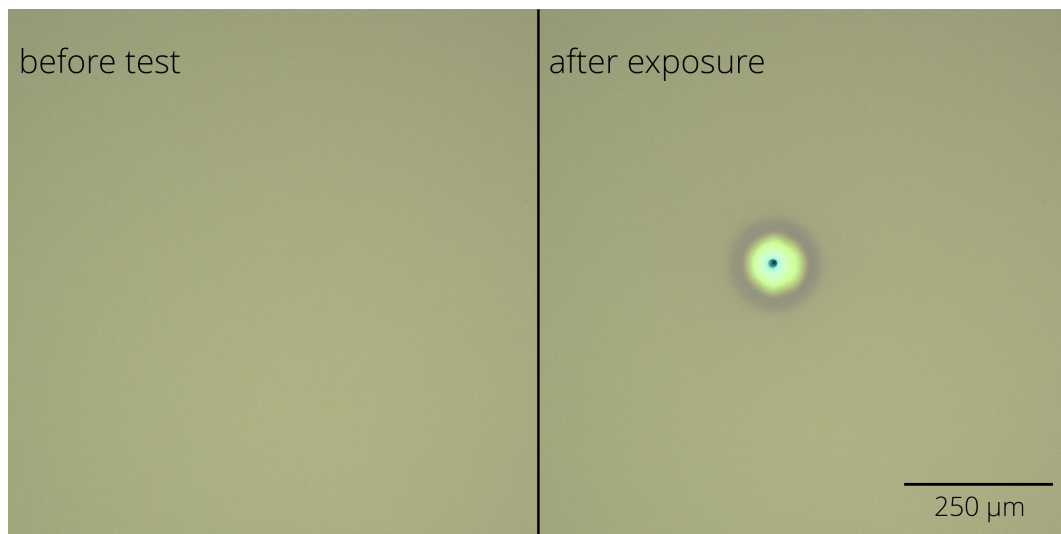
Figure 5. Typical damage morphology: fluence  $58.6 \text{ J/cm}^2$ , damage after 4 pulse(s).

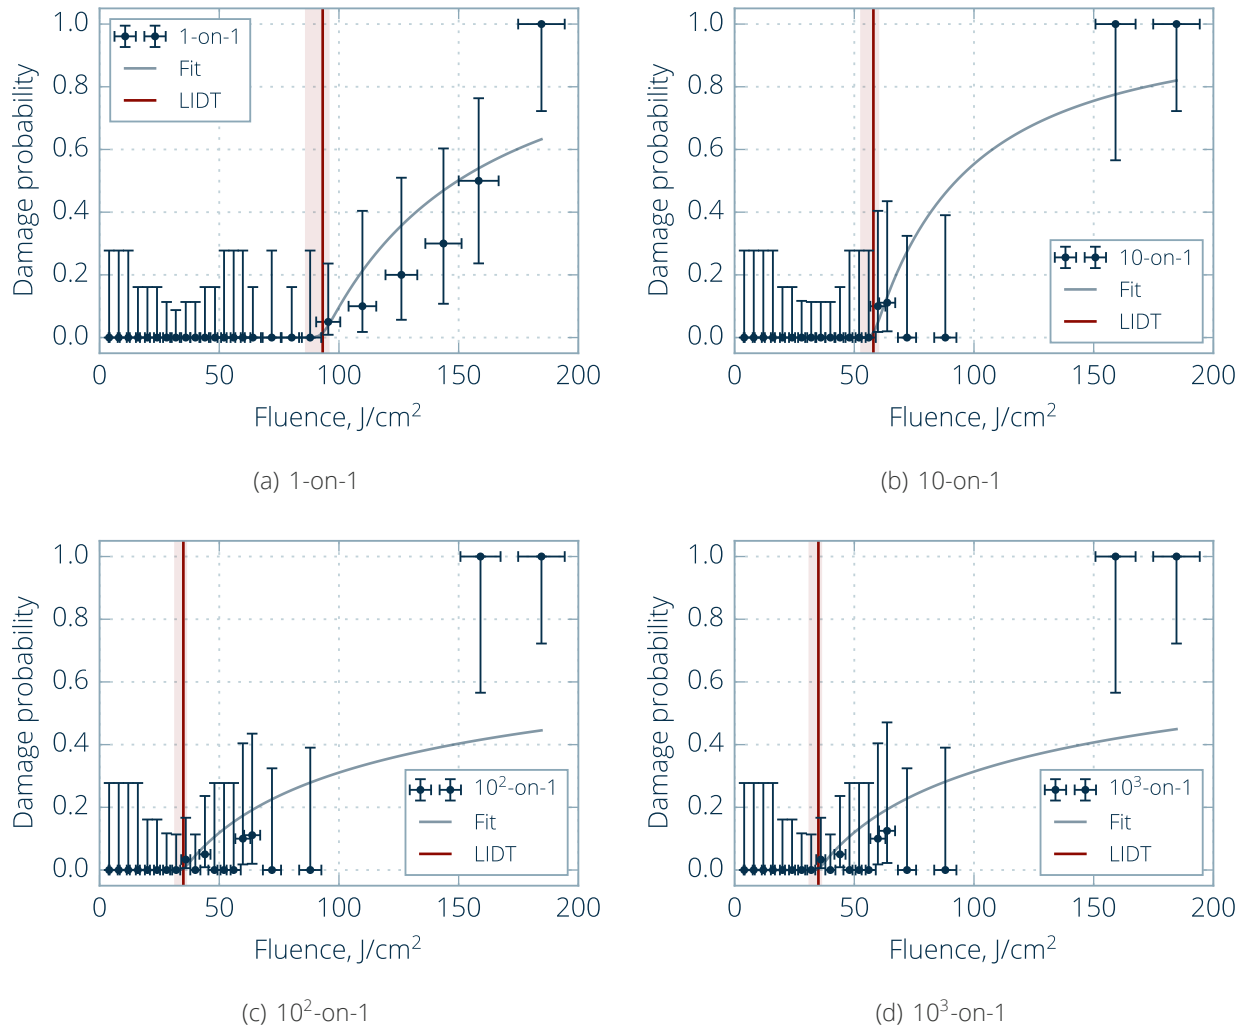
Figure 6. Damage probability plots.
